# Electrical Transmission and Substation Structures 2012

Solutions to Building  
the Grid of Tomorrow

PROCEEDINGS OF THE 2012 ELECTRICAL TRANSMISSION AND  
SUBSTATION STRUCTURES CONFERENCE

November 4–8, 2012  
Columbus, Ohio

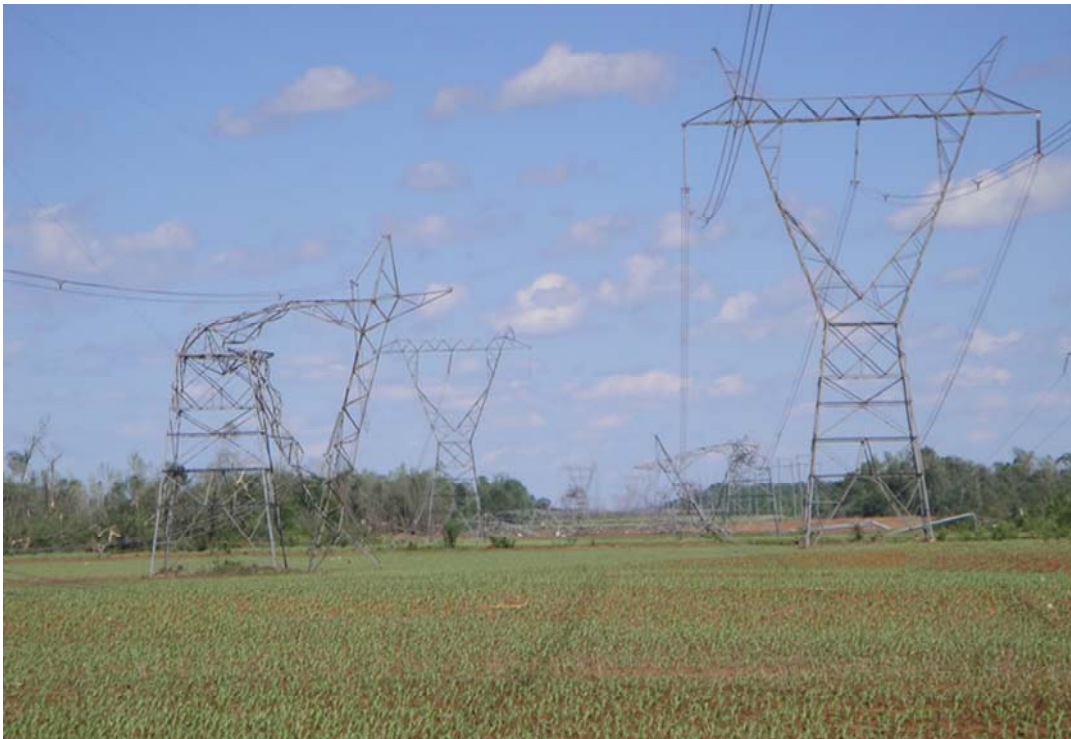
Figure 4. Damaged 500kV corridor near Athens, Alabama (courtesy of TVA)

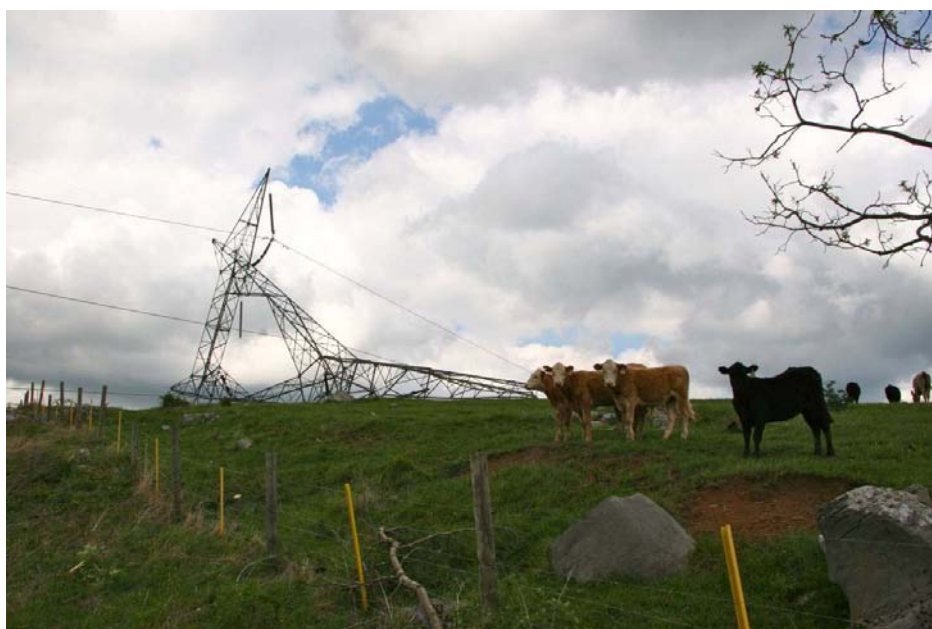
**Figure 2 – Destroyed 500kV Tower**

The initial plan was to remove damaged towers and associated material using trucks, cranes, and other heavy equipment. This effort would take several weeks. Helicopter removal was then investigated and deemed a viable option. Two helicopters were used to remove the damaged towers and materials. Using helicopters shortened the site clean-up to less than one week for the removal of all damaged structures. This also enabled the foundation crews to begin concrete pier installation sooner than expected. In contrast, removal by truck would have required access road construction first, therefore delaying pier installation by several weeks. A typical destroyed tower location is shown in Figure 2.

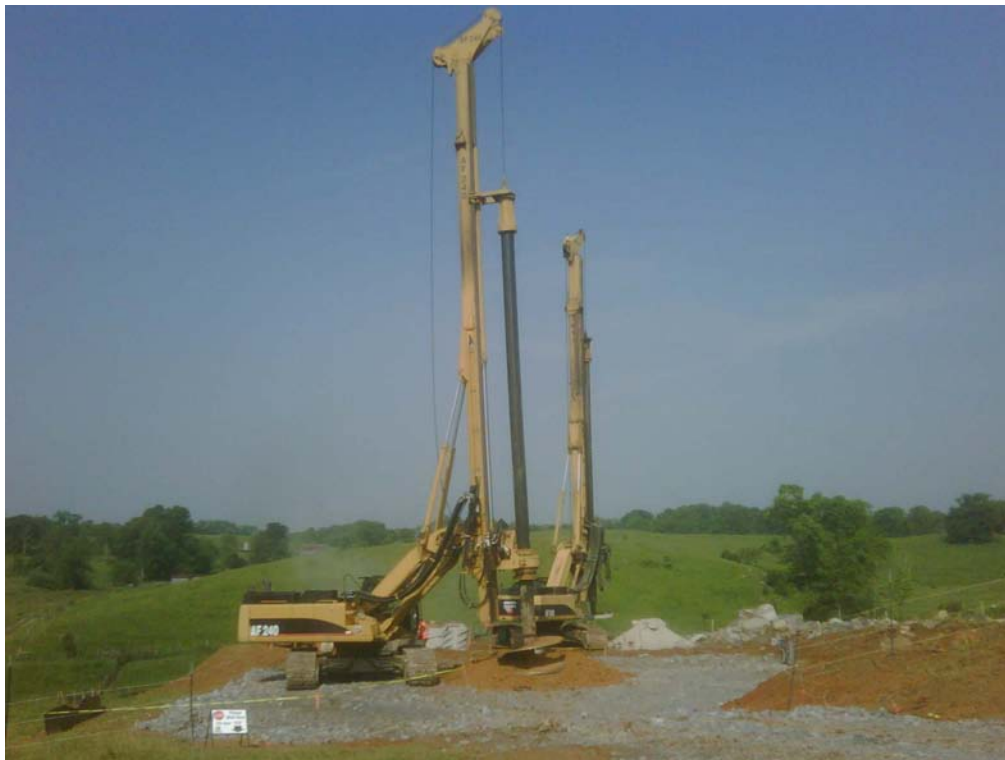
**Figure 5 – IMT AF 240 Drill Rig**

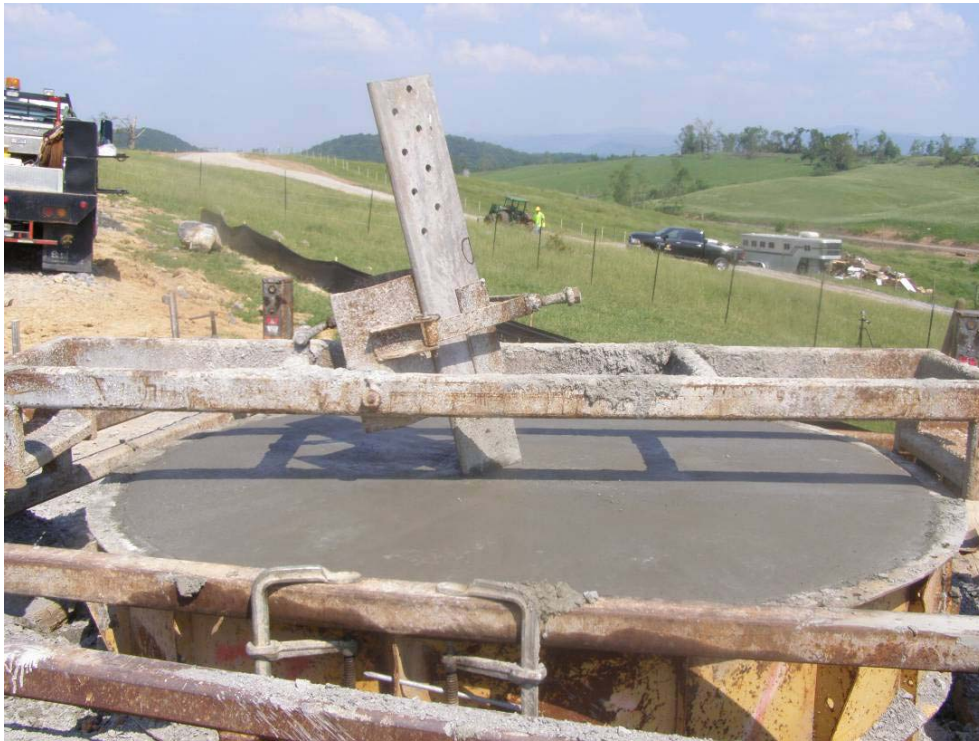
Figure 6 – Concrete Form with Stub Jack and Positioner

A second piece of specialty equipment called the “stub angle positioner” (Figure 6) was mounted to the top of the stub jack to hold the stub angle in-place. The final position and orientation of each stub leg was established by surveying the control point (top of each stub leg) with the Trimble unit, checking both the angle of rotation (twist) and vertical position. The stub angle batter was checked by a digital protractor.

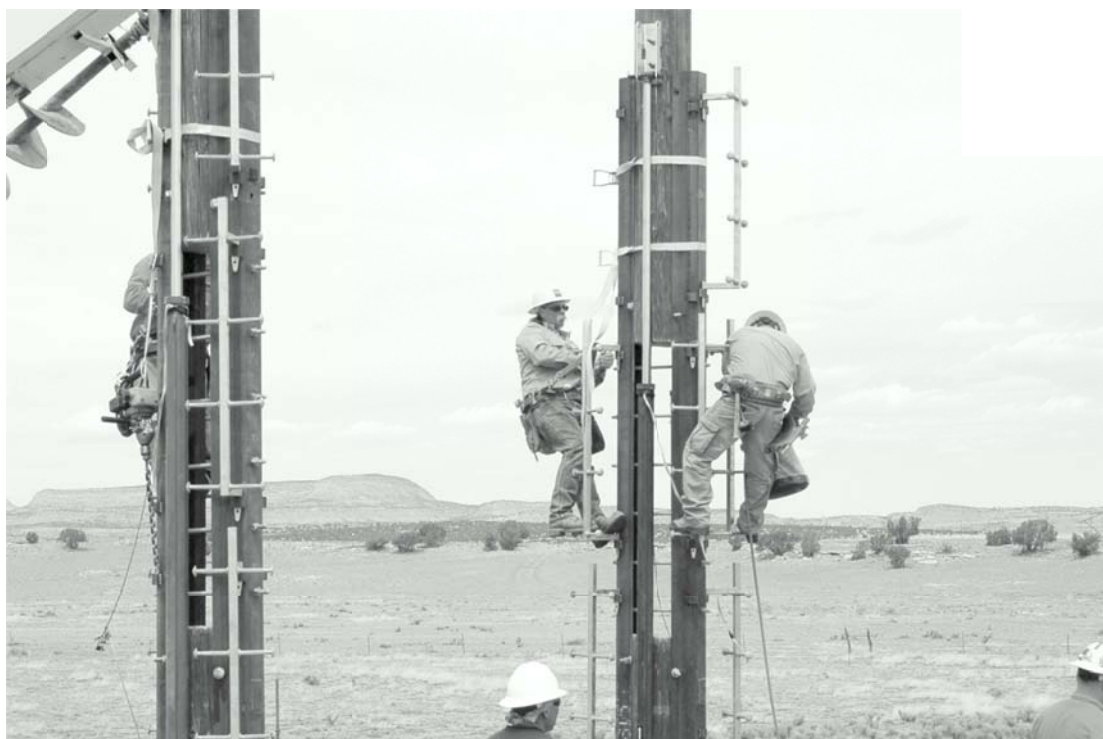
**Figure 3: Installation of Phase Raiser<sup>®</sup> Assembly is shown on a 115kV H-frame Structure. Assembly shown lifts structure six (6) feet. (Photo courtesy of PNM.)**

To evaluate the suitability of retrofitting existing structures, PNM conducted structural testing on typical aged structures. This was to determine the strength and condition of both the wood poles and the framing. PNM with LWS then conducted full scale testing of the Phase Raiser<sup>®</sup> product on aged structures taken from the PNM system. This was done to assure that the product provided the required strength, connection details were adequate, and that specialty tooling was easy to use. The use of Phase Raisers<sup>®</sup> increases moment at the base of the structure. In some instances, a cross-brace is added to the structure to reduce this moment. Phase Raisers<sup>®</sup> are suitable for tangent structures and can be installed with the transmission line energized.

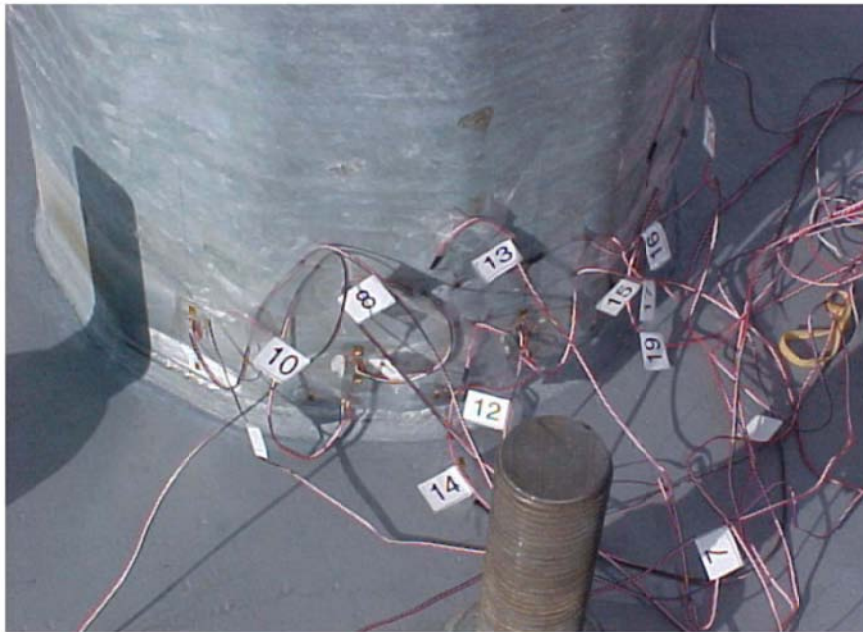
**Figure 3. Strain gage testing**

The outcome was a process for adequately sizing the internal diameter of the ring which was based on the ring material thickness and the pole shaft inside diameter (flat-to-flat). We found that the base plate material on the inside of the shaft ceases to add any stiffness beyond the ratio defined.

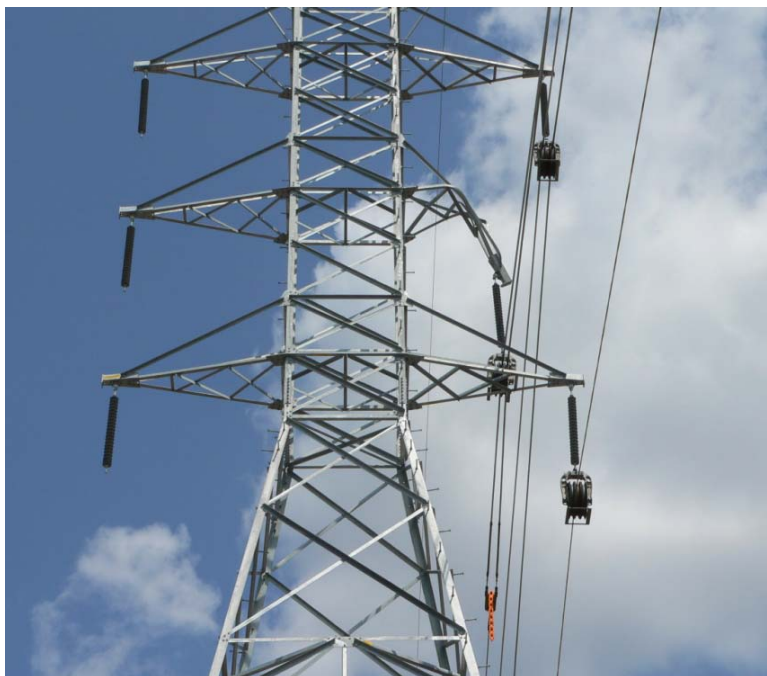
Figure 8. Longitudinal View of Arm Failure

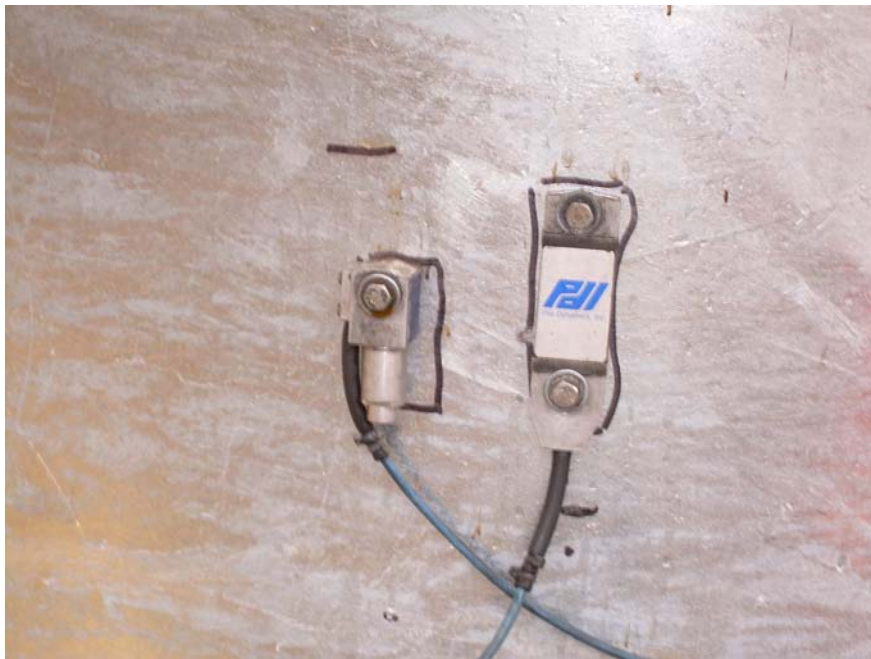
**Figure 11. Accelerometer and Transducer Bolted to Pipe Pile for Dynamic Pile Testing**

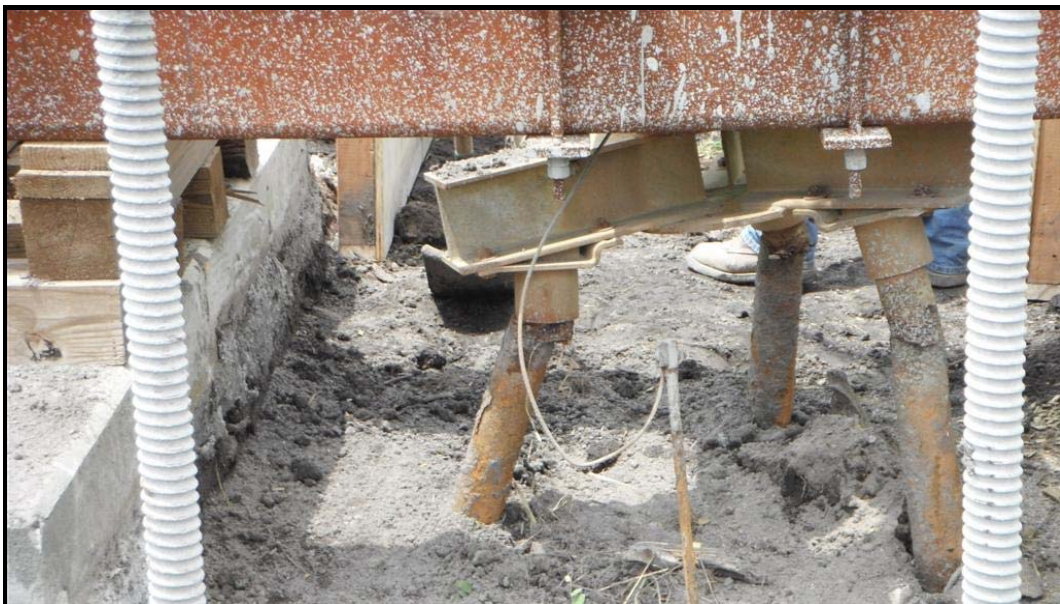
**Photograph 14 – Middle Tower Exposed Grillage Foundation with Severely Corroded and Displaced Anchors**

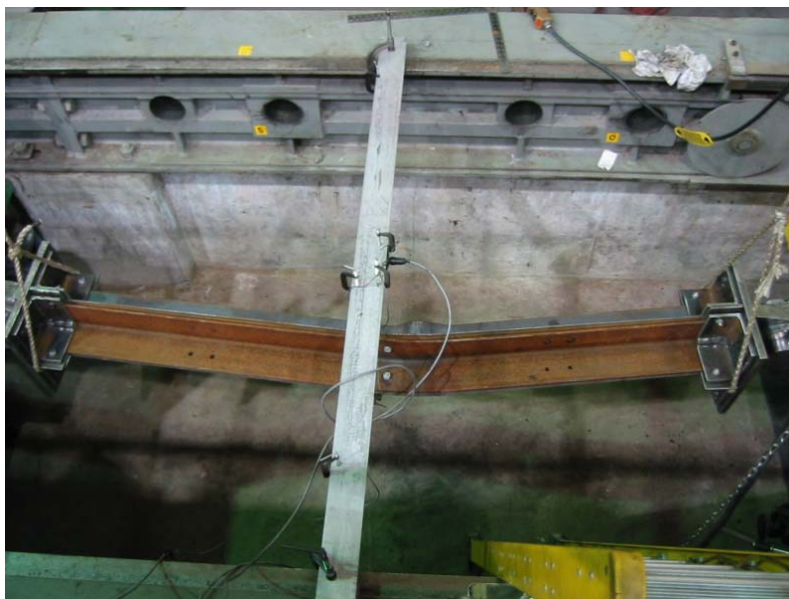
Figure 6. Horizontal test configuration

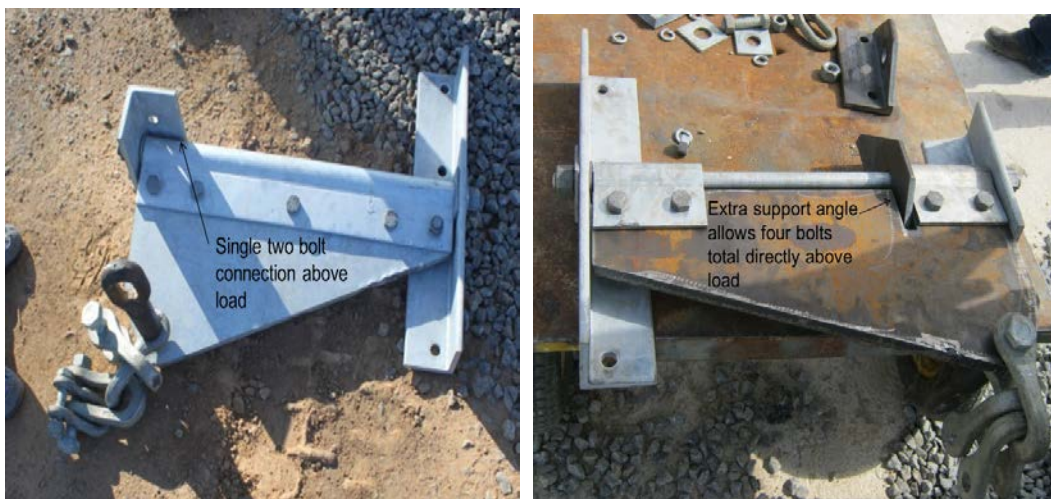
**Figure 6 - Failed bracket configuration    Figure 7 - Configuration passing testing**

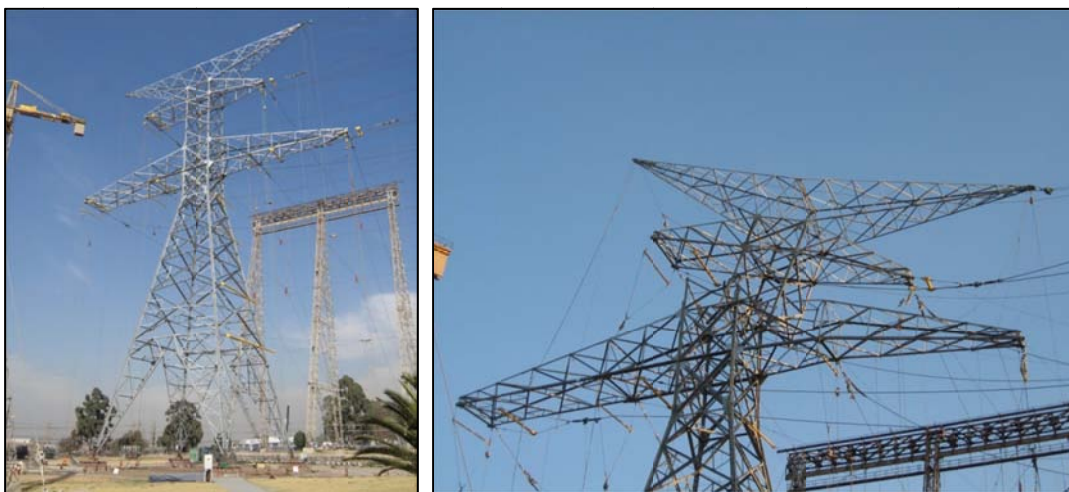
**Figure 3. D5E NESC Heavy test, and top section failure, Johannesburg, SA.**
